WARD HALL, GEORGETOWN, KENTUCKY

EXTERNAL ENVELOPE RESTORATION PLAN: PHASE 1

Revised Draft, 17 March 2012

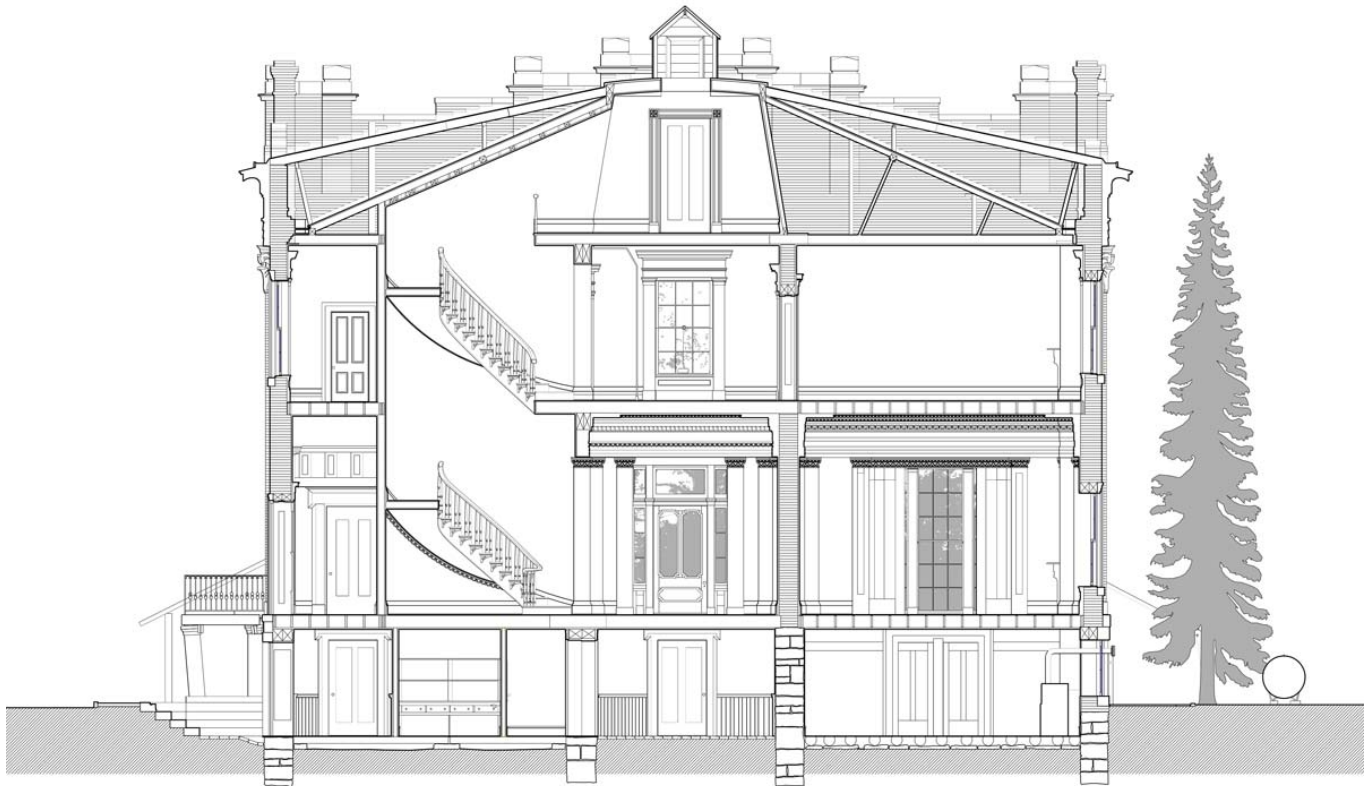
Figure 25. A current condition cross section through the West Entry and the main, nautilus staircase of Ward Hall, looking North . Note the double roofs, the shoring supporting the failed second roof at the chimneys, and the clapboard-sided lantern that has provided little or no light to the Attic landing or, for that matter, the otherwise unlit stairwell, in decades.

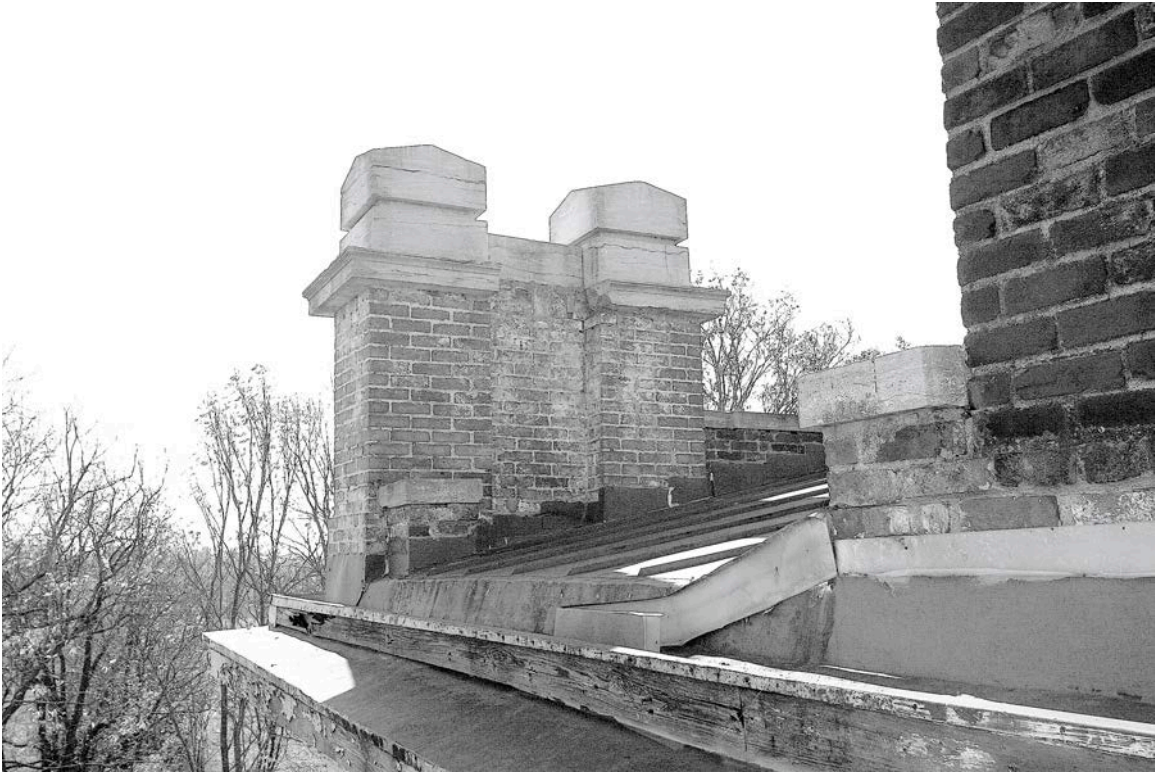
Figure 26. The second roof projecting over the lowered parapet wall at the southeast corner of the building and in the corners somewhat perversely allowed to occupy the new gutter constructed on the top surface of the cornice to collect its run-off.
Photo, Anthony Eardley, 31 October 2007.

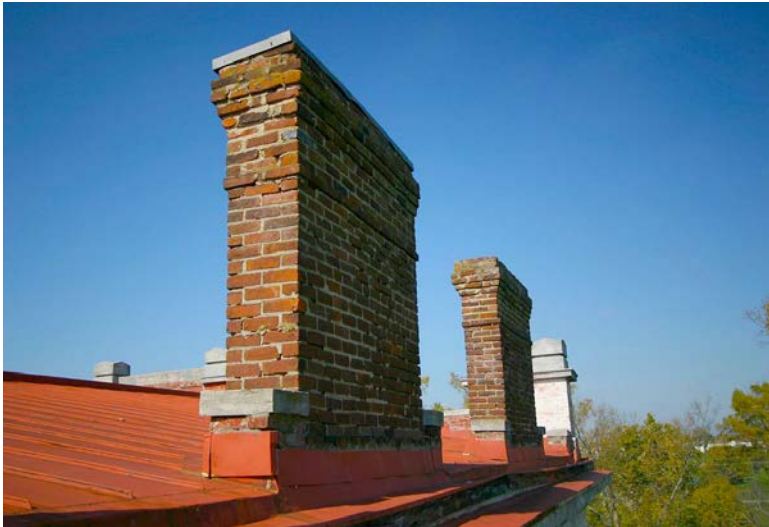
Figure 30. Two of the three East side chimney stacks. *Photo, Anthony Eardley, October 2007*

were removed and replaced with brick. These stacks have been subjected to various crude attempts at repair with Portland cement mortars and are now in very poor condition. So too, are the pilaster capitals and much of the classical entablature below the stacks..

Next, masons employing their own, additional scaffolding from the cornice level of the house on up, will dismantle and rebuild all six chimney stacks, recovering and cleaning as much of the original brick as may be possible, mixing in other, closely matching old brick as necessary, and capping the rebuilt stacks with newly fabricated limestone replicas of the original caps. These caps appear in Figure 1, and one or two of their broken components have been located in the foundation of a former henhouse, about 150 yards away from the mansion. Since each of these stone elements will weigh about 500 pounds, a mobile crane will be used to facilitate setting them in place. The portions of the North and South gable walls that were raised to conceal the higher, second roof profile will be taken down, and the top courses of the original parapet walls that were taken down to cornice level to facilitate the second roof's construction, will be rebuilt with limestone coping stones to match the original, their height to coincide with the limestone string courses built into the outer flanks of the North and South gable ends. The mortar will be an appropriate lime mortar in compliance with The Secretary of the Interior's Standards for the Treatment of Historic Properties. The finish joints will be struck and ruled to match the original masonry joints. This work is expected to take between 15 and 20 days and to cost of approximately **\$75,000.00**, of which about \$15,000.00 will be expended on materials: matching bricks, dimensioned limestone and mortar.

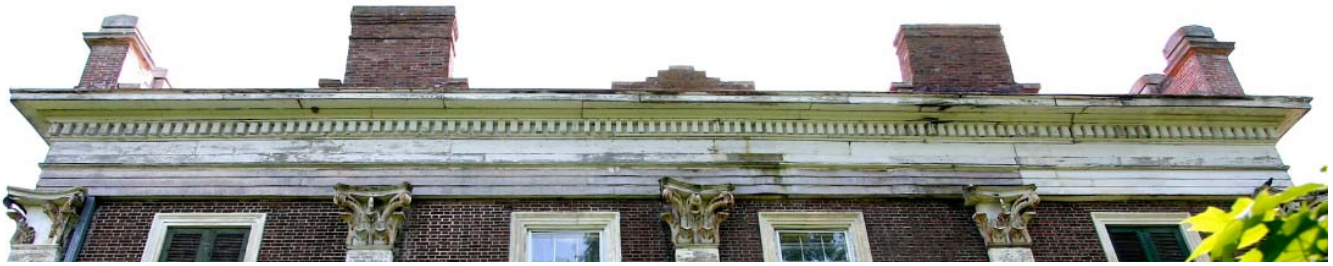
Figure 31. West side entablature. *Photo, Anthony Eardley, June 2008*

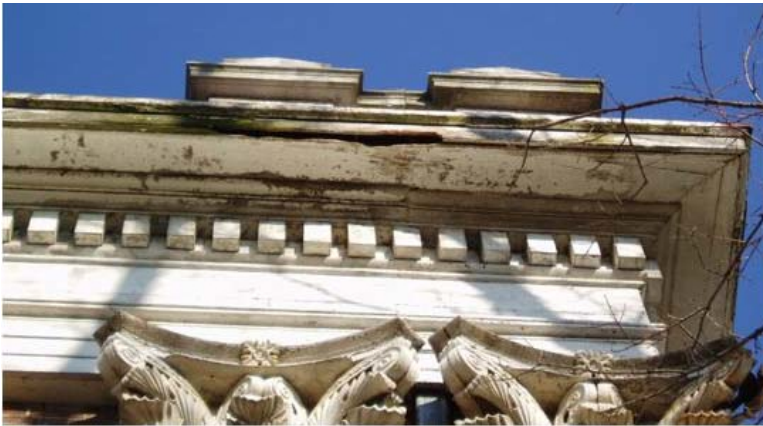
Figure 32. The underside of the cornice at the southeast corner. *Photo, Kentucky heritage Council report, December 2004, figure 12*

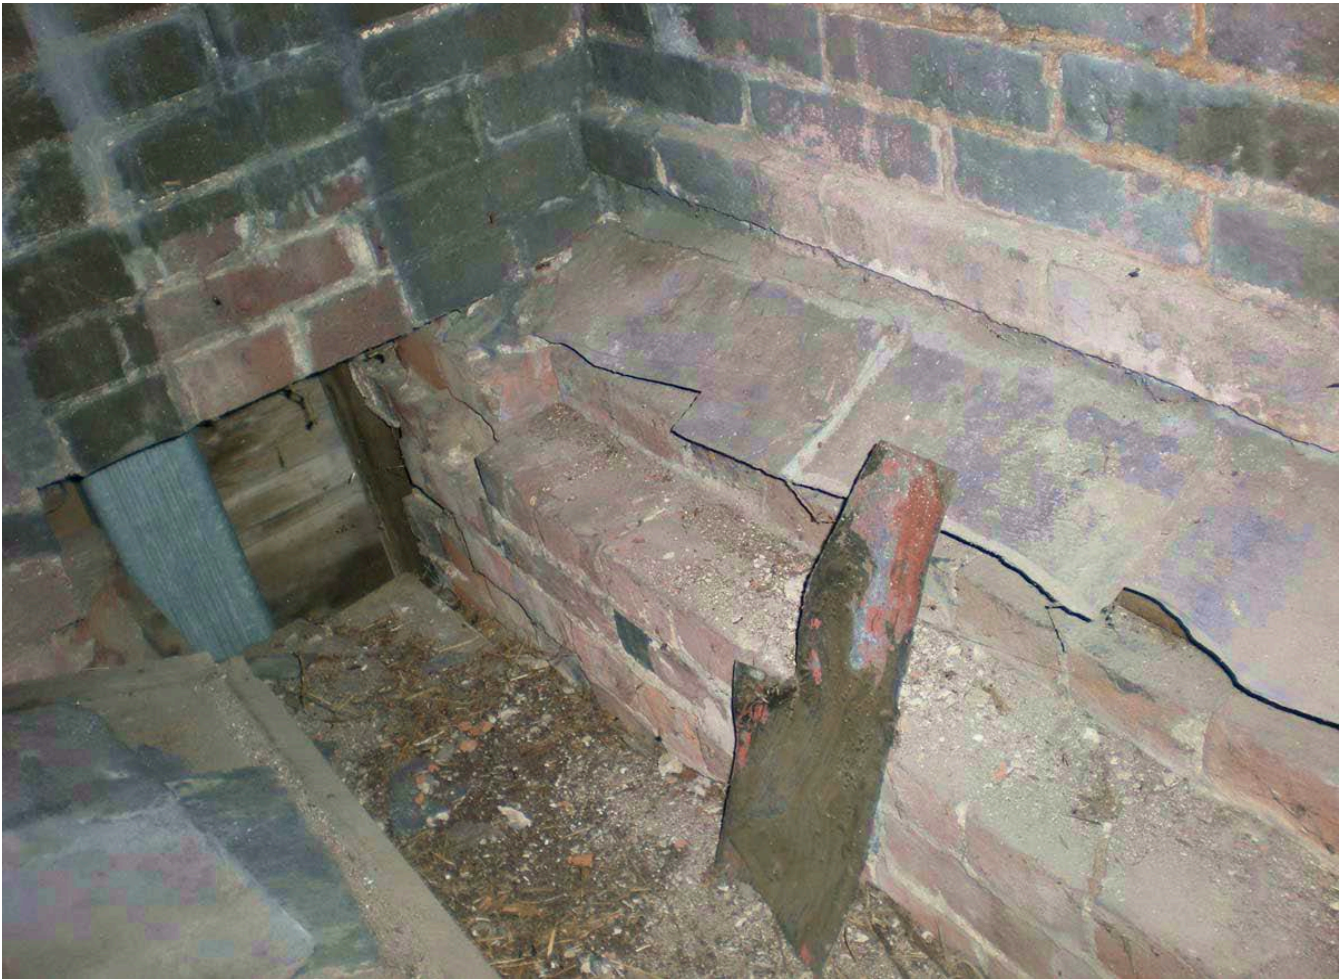
Rather, the purpose of the second roof system would appear to have been to reduce the incidence of negative wind pressure on the roof, and to ameliorate the severity of the problems of wind induced downdraft that must have plagued the original configuration, as evidenced by the heavy accumulations of soot on the inside faces of the parapet walls, and seen in Figures 33 and 36.

Figure 33. The hopper end of one of the original gutters running inside the East and West parapet walls, stripped of its lead lining some time after the installation of the second roof above it. Note the contrast between the soot-grimed walls, exposed to chronic downdraft smoke effects for perhaps the first twenty years of the life of the building, and the clean, formerly protected brickwork to the outside of the gutter. *Photo, Geoffrey Bell, November 2008*

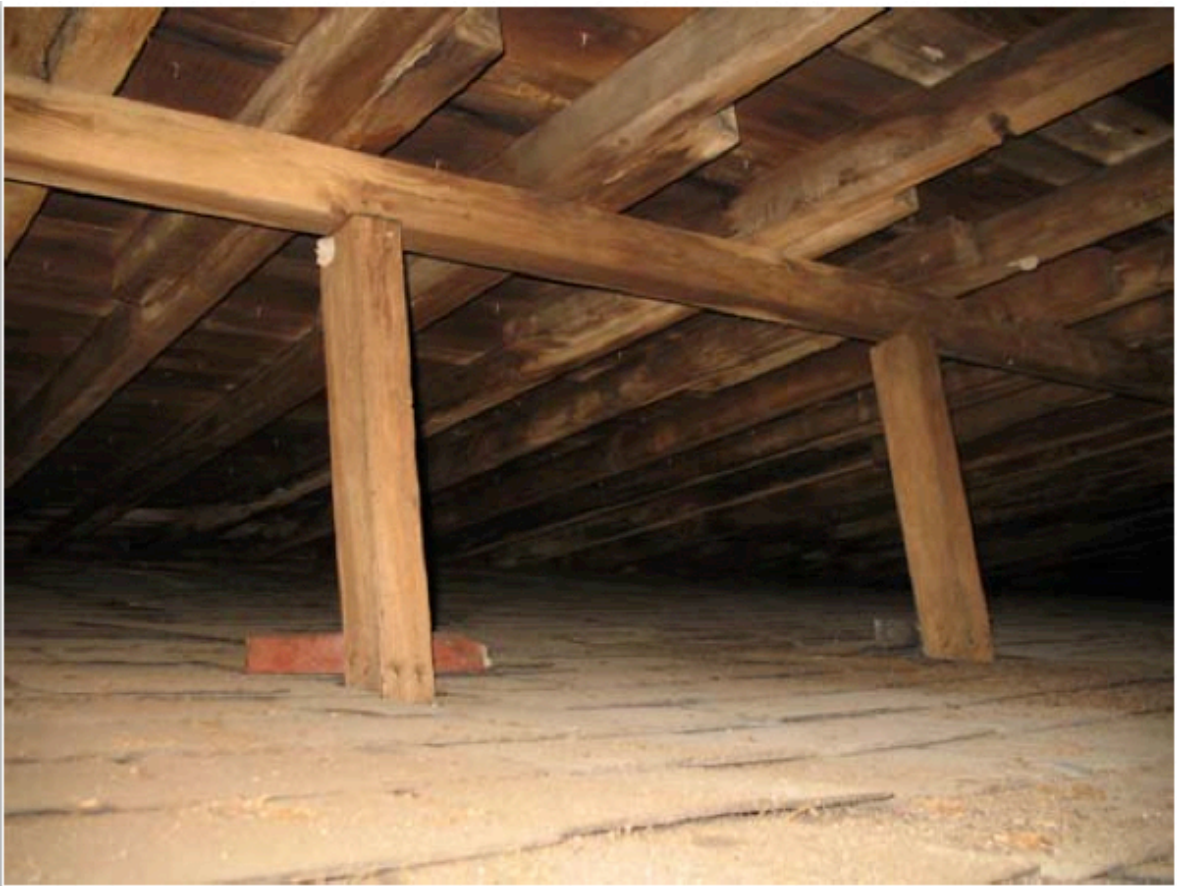
Figure 34. This shows the rafters of the second roof lying overlapped across a mid-slope purlin, which bears on posts supported by the original slate roof. *Photo, Jerry Fryer, Structural Inspection Report, Revised December 5, 2008, BFMJ Structural Engineers, Lexington, Kentucky.*

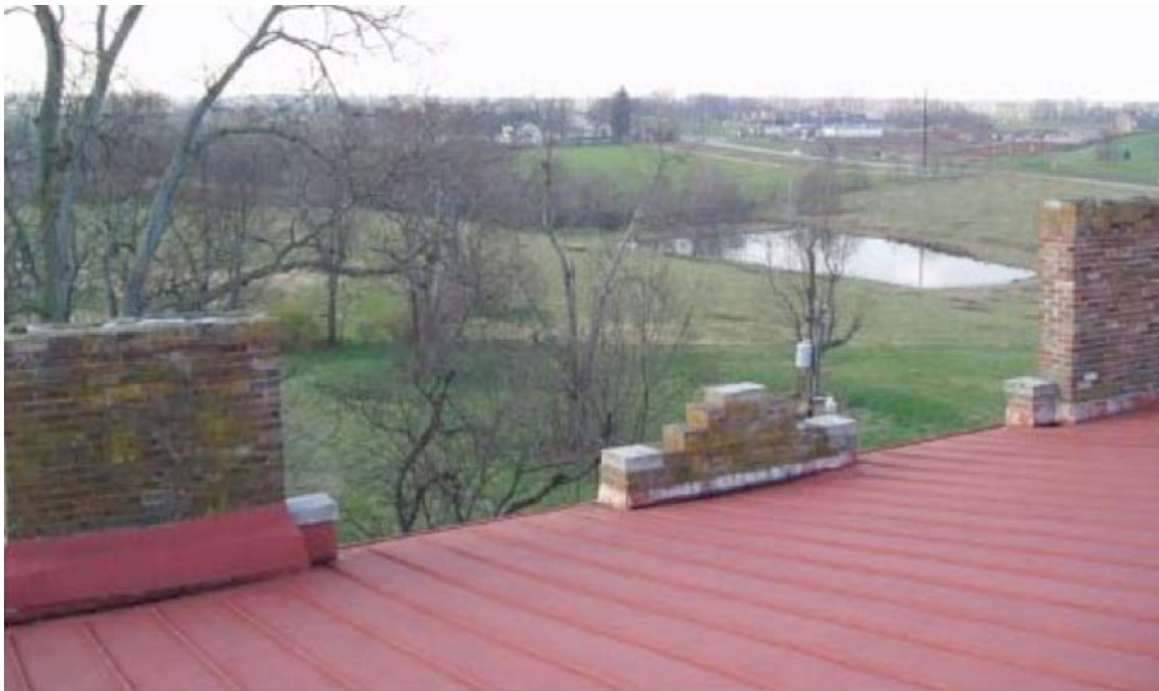
Figure 35. View across the Western slope of the second roof, showing the impediments to drainage created by the chimney stacks. *Photo, Kentucky Heritage Council Report, December 2004, figure 78*

and its water shedding capacity has always been compromised by the presence of the six broad blades of the chimney stacks and their inexplicable abutments, which, having no crickets on this shallow slope, to divert the flow of water around them, severely hamper its fall to the cornice-top gutters out beyond them. Numerous failures in both the first metal membrane and the flashing at the intersection of the second roof with these chimney stacks has led to leaks, rot and structural failures, replacement metal, new leaks and further structural failure, recreating a state of progressive disrepair and causing the interior of the house to become increasingly vulnerable to water damage (13).

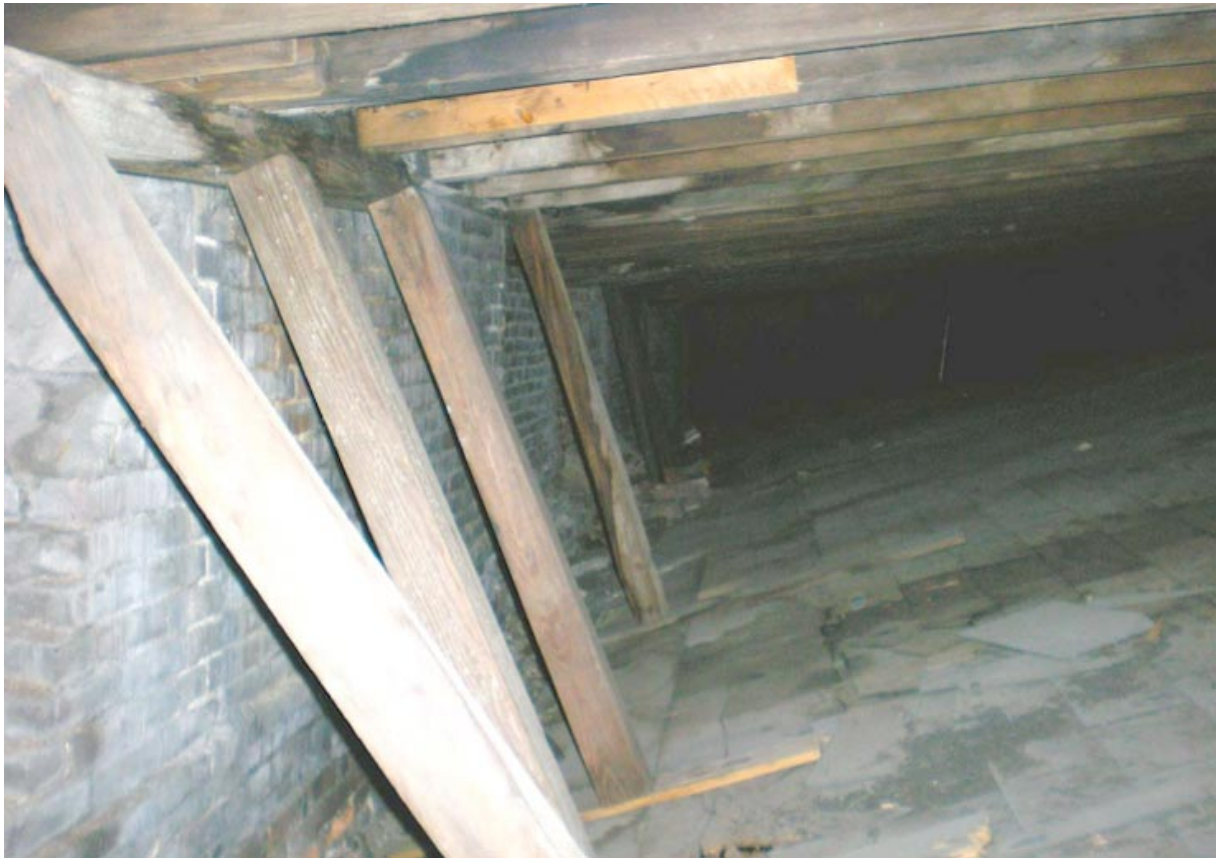
Figure 36. The space between the first and second roofs, showing the shoring typically necessitated by the failure of the upper roof structure at the chimney stacks. *Photo, Geoffrey Bell, November 2008*

The first trade involved in the project will be the carpenters, who will have to work in the space between the two roofs to rebuild the original box gutters before the second roof can be removed in collaboration with the roofers, one section at a time, one side at a time. As each section of the original roof is exposed, all of its remaining and severely delaminated, spalled and crumbling slate will be removed, and the exposed roof boarding will be covered with a 5" layer of rigid insulation, providing an R-value of 30, and 5/8" plywood sheathing, to which a 40 millimeter, high performance underlayment will be applied. This latter will make the roof watertight while the masonry work is being carried out. This stage of the work will take about 10 days and cost **\$61,500.00**, including \$16,000.00 for the cost of the insulation material.

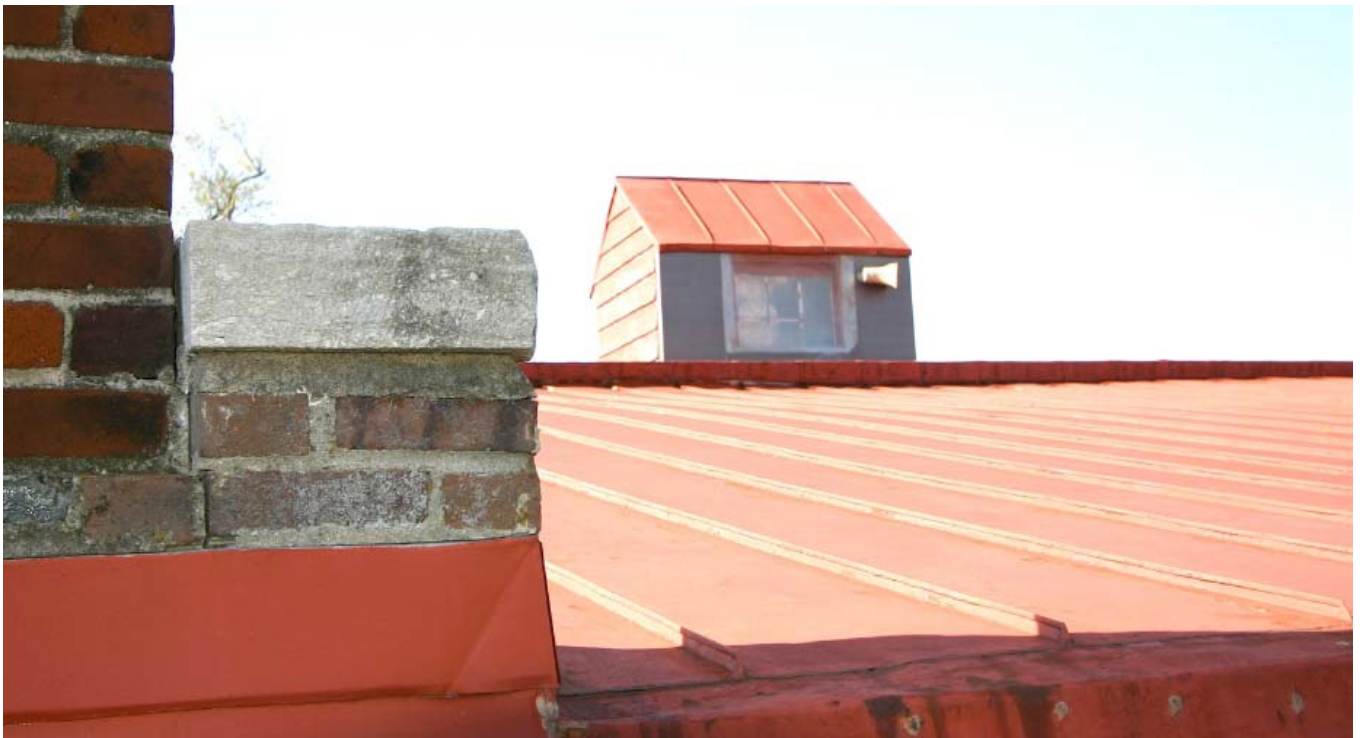
system has entirely supplanted any concern for the provision of daylight to the major vertical circulation system of the house, and the incongruous and leaky appendage presently found on the attic landing roof more closely resembles an abandoned dog kennel, inexplicably put back into service up there, than the proud ornament that so frequently crowns Greek Revival buildings.

Figure 39. The present clapboard and sheet metal structure with a door and two meager windows. *Photo, Anthony Eardley, October 2007*

Lacking any image of the original lantern, if, indeed there ever was an original “lantern”, and offered neither a Minard Lafever or other pattern book precedent, nor any earlier Lewinski lantern that might have informed a design for Ward Hall – clearly Lewinski never ever thought about a building’s need for daylight -- the Board has opted to replace the present structure, with a low profile, insulated, copper framed skylight with clear insulated glass such as is seen in figure 41, below, this to be equipped with an electronically operated ventilator and damper.

A sum of **\$18,500** has been allowed to build, ship and install a replacement lantern.

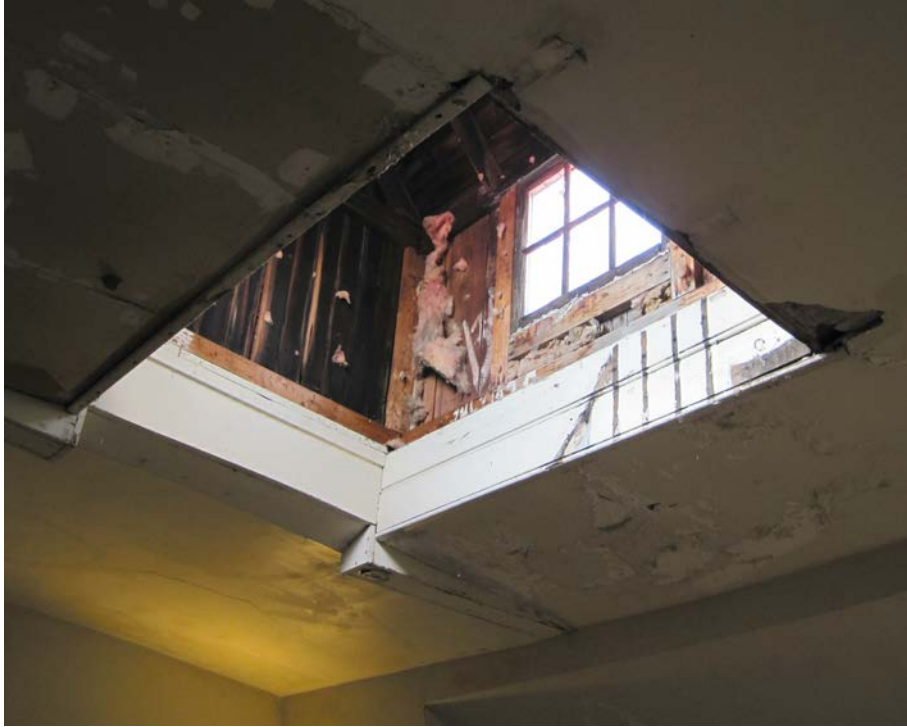
Figure 40. Interior of the present penthouse on a bright day. Note the need for supplemental lighting. *Photo, Anthony Eardley, April 2010*

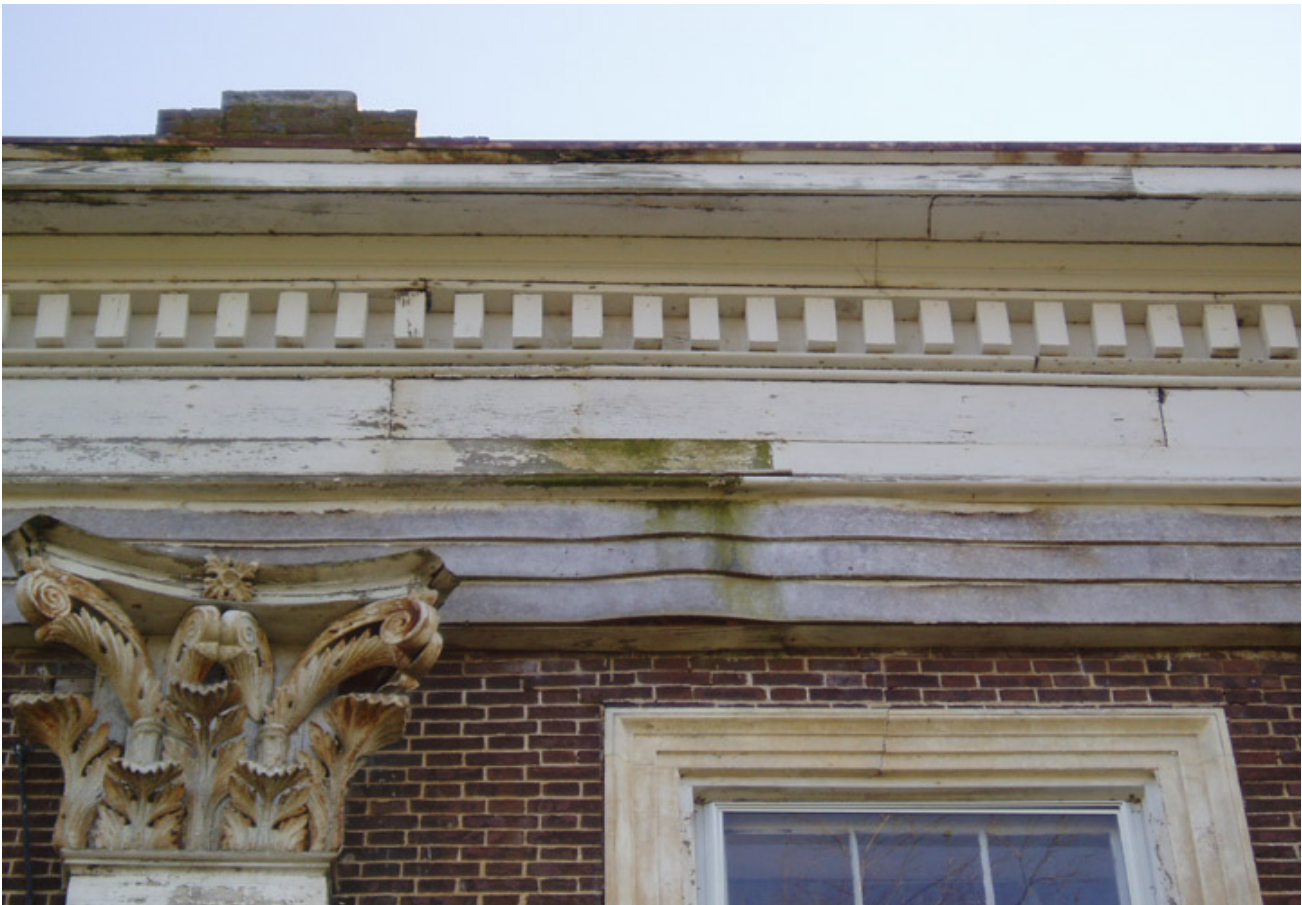
The six-foot-high wooden entablature, soffit and cornice embracing the building (but not including the North portico, which will be renewed in Phase 2, once the podium has been rebuilt), have a surface area of roughly 2,500 square feet. Much of this surface has deteriorated as a result of cornice leaks, water penetration, and repairs with inferior materials, as seen in Figure 42.

Figure 42. An example of past entablature repairs with inappropriate and inferior materials.
Photo, Kentucky Heritage Council Report, December 2004, figure 7

It will be not possible to arrive at an accurate estimate of the time and materials costs for the carpentry repairs to the entablature until the scaffolding has been erected and a close inspection of the deterioration can be made. For the present purposes, an allowance of about

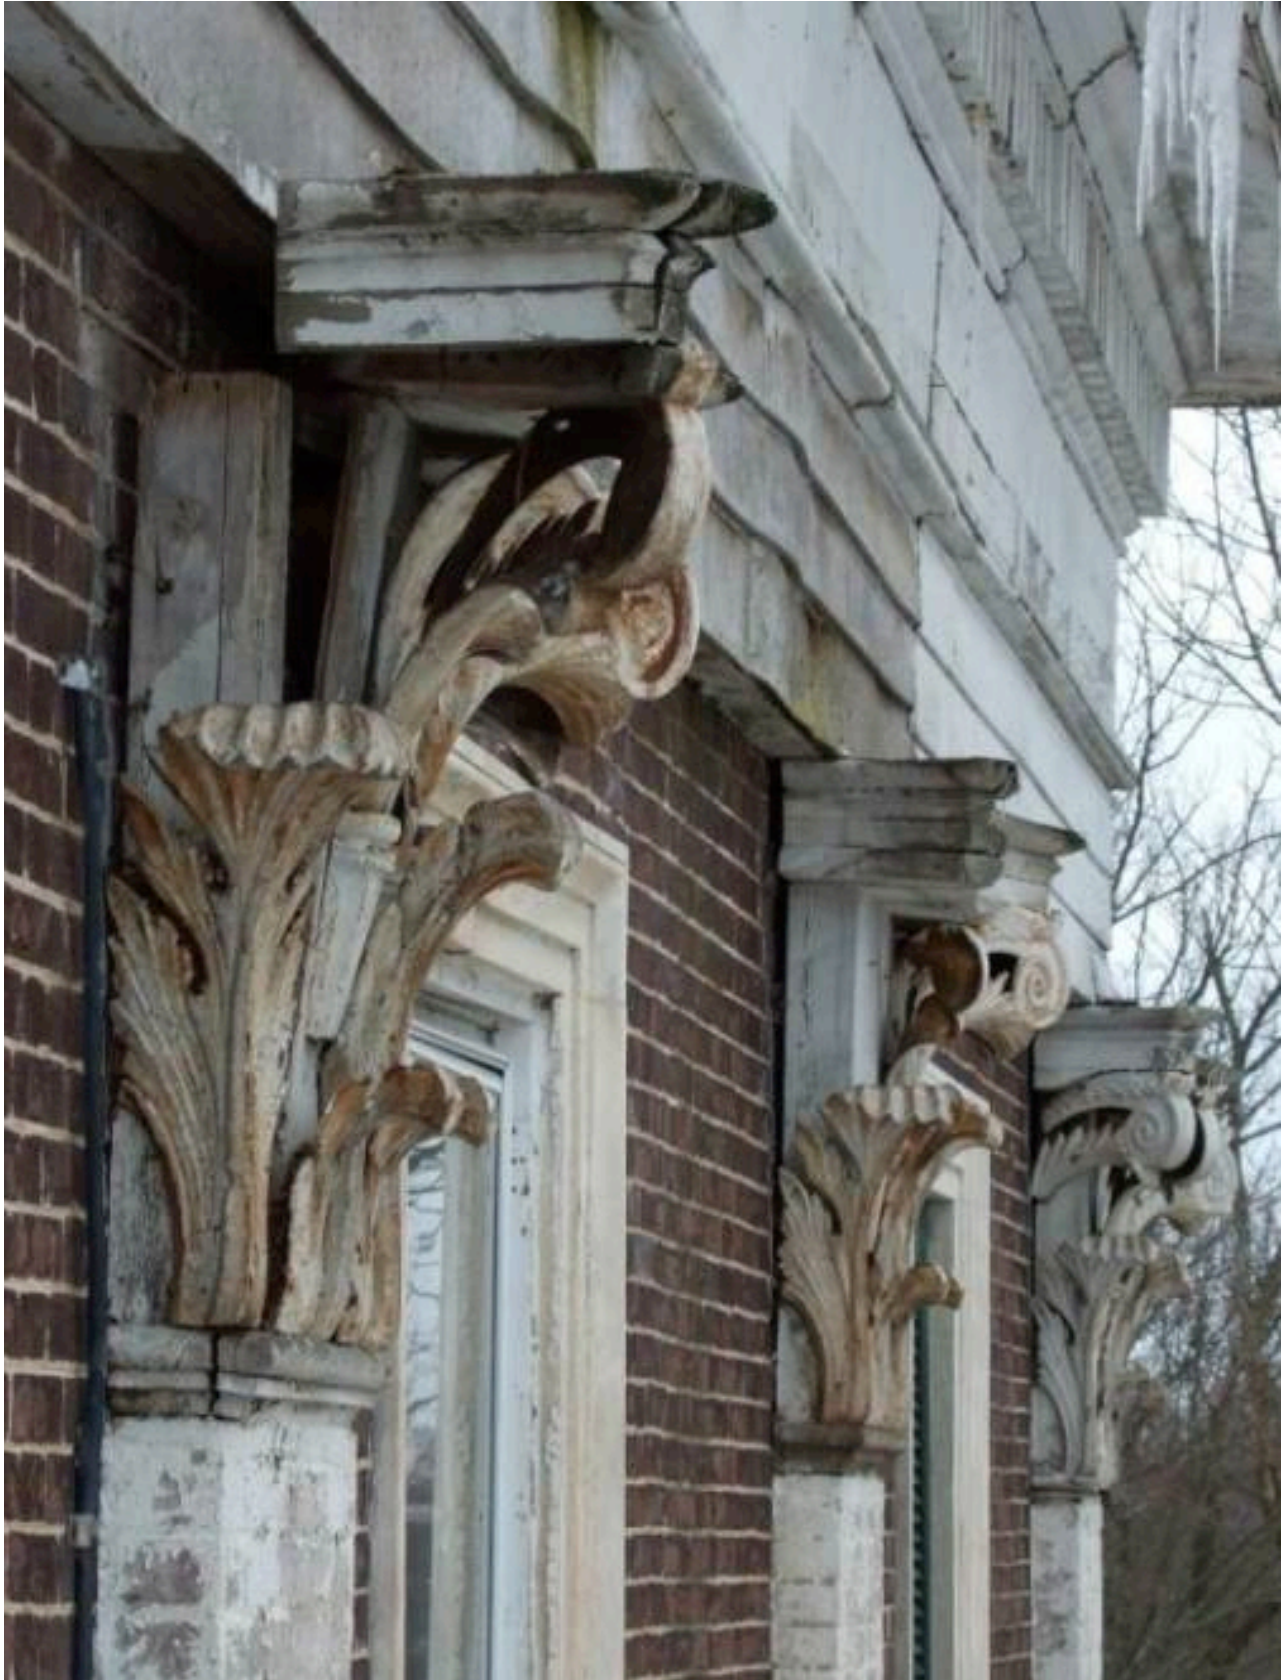
Figure 45. A 2007 view of the worst deterioration of the pilaster capitals on the West façade, the closest of which is now entirely disintegrated.
Photo from Alison Brown, Conservation of the Cast Iron Pilaster Capitals at Ward Hall in Georgetown, Kentucky, Spring 2007

Ms. Brown's 2007 tabulations showed that some 76 pieces of these assemblies were missing, having been either removed or fallen from the capitals and broken on the perimeter paving below. There are still more components with corroded screws and rusting baling wire attached to rotting wooden cores that exhibit imminent likelihood of the same outcome. There are some six components that, though still in place, are broken, and for these Ms. Brown recommended repair.

There is some degree of deterioration to the wooden elements of every one of the twenty-six pilaster capitals. A number appear to need only modest attention while others, especially on the West façade will clearly need to be entirely rebuilt. An allowance of five weeks and **\$22,600.00** for time and materials is believed to be adequate to cover the removal and packing of the cast iron components for shipping, the repair and replacement in kind of the wooden components of the capitals, and the reattachment of the cleaned cast iron after the restored woodwork has been primed and painted.

This is not the recommendation of the foundry we have consulted, however, who informed us that repairs to cast iron are not reliable and, given that we shall have to make new molds and castings for every component part of the capitals in any case, that it will be more economical and effective simply to replace the broken pieces with new castings.

The work will take eight to ten weeks from the foundry's receipt of sample components and is expected to cost **\$39,000.00**. This will include the making of all eleven of the different casting patterns, some 80 or more castings, machining for the mounting holes, pre-prime painting with zinc-rich urethane, priming with two-component epoxy and delivery from the Robinson Iron Foundry in Alexander City, Alabama, to the site.

The approximately 260 cast-iron components still in place will need to be removed for cleaning and restoration, and to permit the necessary repairs to the deteriorated timber bases. The cleaning of these pieces by the Robinson Iron Foundry would take three to four weeks and cost **\$18,250.00**. This would include the costs of pick up and delivery to Ward Hall, cleaning via glass-bead blasting, and pre-priming and priming as described above.

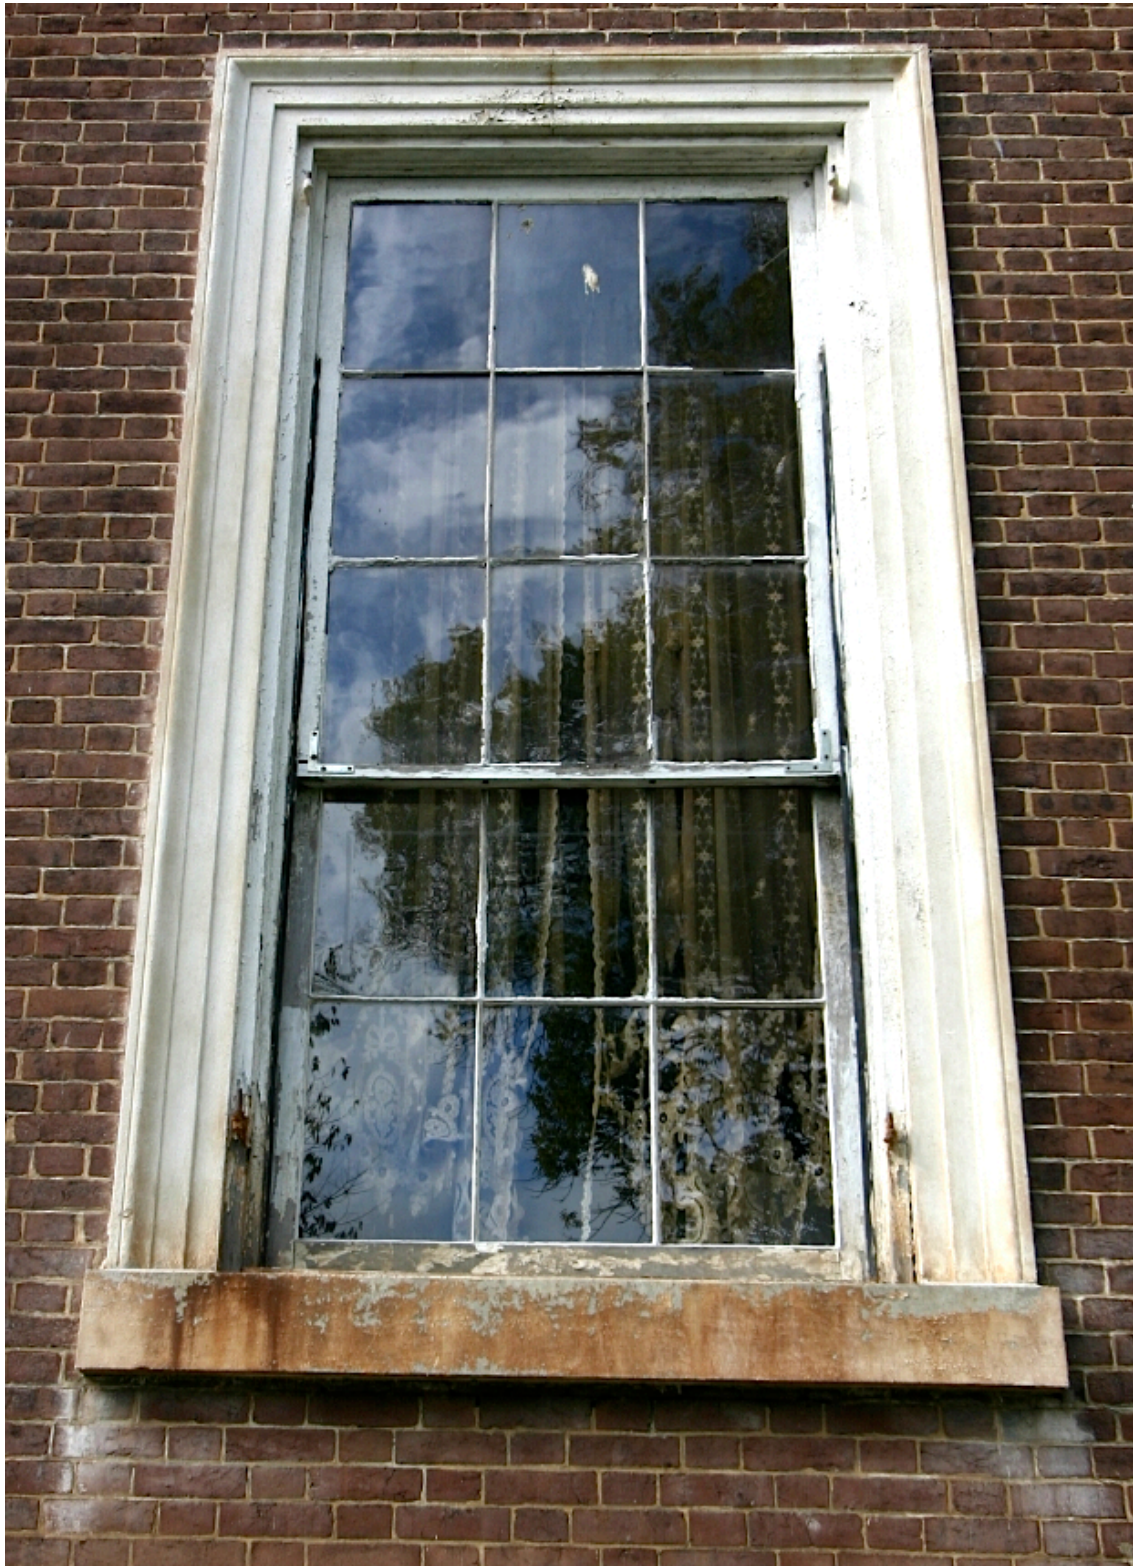
All of the window frames of the building have suffered some deterioration, especially to the bottom rails of the sashes, which need repair or replacement in kind. The glazing putty needs to be replaced throughout. The fixed shutters covering blind windows are similarly deteriorated, and all the windows on the East and West sides lack operable shutters. It should be said, in passing, that there is no evidence of the existence of external shutters on the North and south facades. The windows on those elevations are equipped with internal shutters.

Figure 46. A nine over six double hung sash window in the East façade of the building, exhibiting typical problems of painted stone architraves staining the brickwork beneath the sill, paint loss to the woodwork, glazing putty loss, and failed frame connections to deteriorated bottom rails. There are no operable shutters to be found for these East and West side windows. *Photo, Anthony Eardley, October 2007*

There are ten double-hung, 'six over six', second-floor windows, each measuring 7' x 4', that should be repaired and repainted while the scaffolding is in place, and on the principal floor there are three larger double-hung, 'nine over six', windows, measuring 9' x 4' (see Figure 21, above) and two very large tripartite windows (11' x 6' 9") each containing 30 panes of glass,. Eight fixed shutters should also be repaired, and there are seven windows on the East and West facades that need new shutters. This work is expected to take approximately ten weeks and to cost **\$33,000.00**
