WARD HALL, GEORGETOWN, KENTUCKY

EXTERNAL ENVELOPE RESTORATION PLAN: PHASE 1

Revised Draft, 17 March 2012

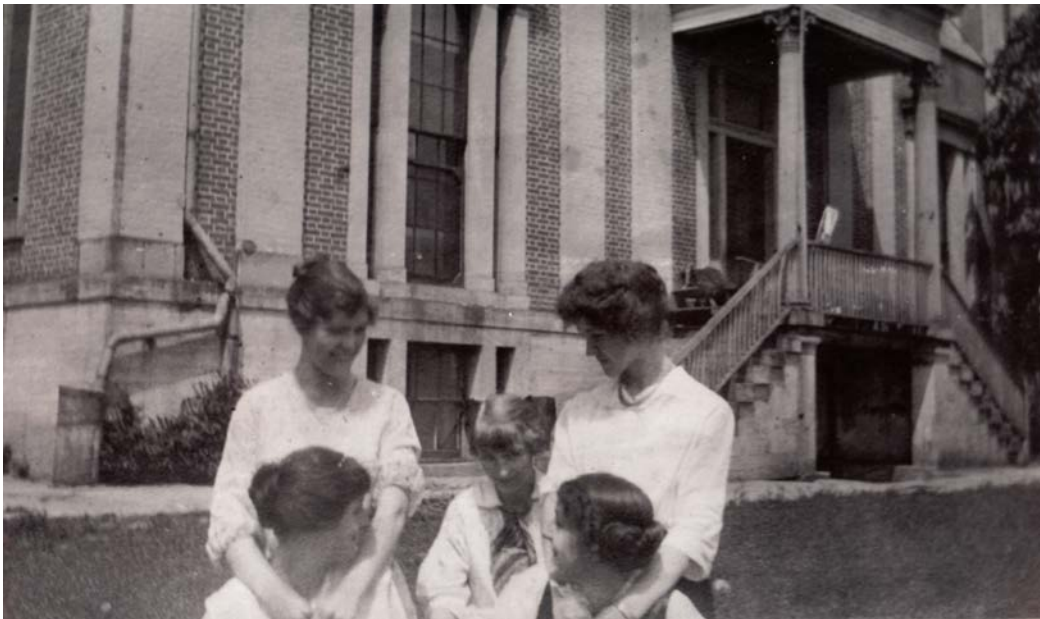
Figure 18. Unknown family members on the South lawn. Note the wooden balustrade to the porch and the “Rube Goldberg” termination of the southwest corner rainwater-pipe, indicating a permanent blockage in the original cast iron pipe system that was intended to convey surface water to the underground storage cistern outside the west Basement doorway *Photo, Ward Hall Archive*

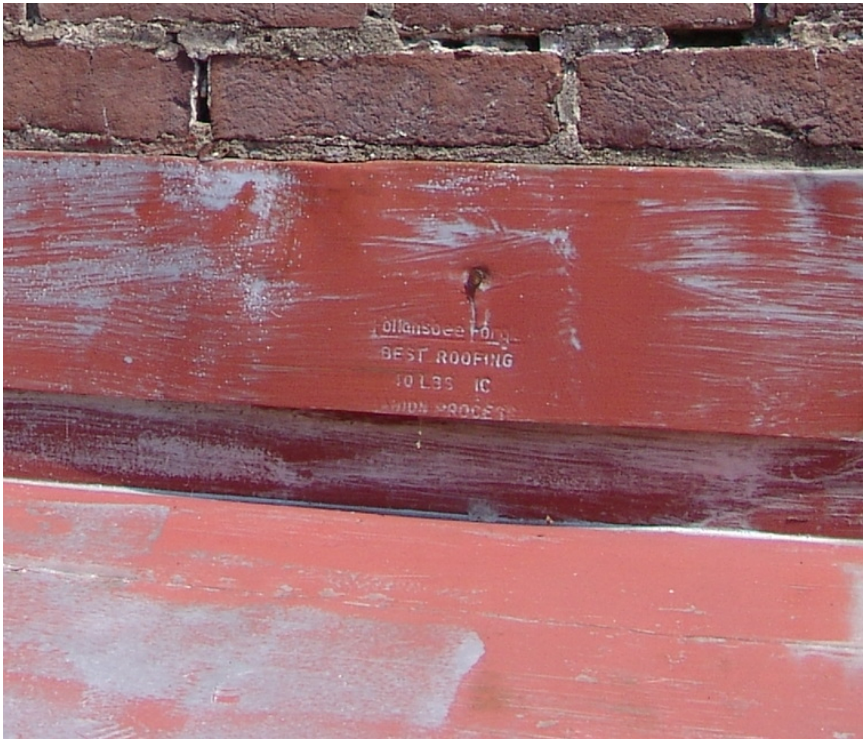
Figure 27. The Follansbee Steel Company's stamped imprint is legible here in this "reversed image" detail of the terne metal flashing to the south gable cornice. This terne metal must constitute a second surface to the superimposed roof structure, installed, not as Clay Lancaster believed, to replace copper that had been stripped for sale during the Civil War ,when this roof did not yet exist, but some time after the Follansbee plant was established in West Virginia in 1902. ,(See *Antebellum Architecture of Kentucky*, p. 230) Photo. Anthony W. Vince, June 2009.

13. Clay Lancaster's *Antebellum Architecture of Kentucky* (p. 230) represents as fact, a popular old saw to the effect that "the sheet copper that covered the roof was removed and sold during the Civil War". Though Lancaster visited the house in 1940 and again in 1964, he clearly was not aware that this building has duplicate roof systems. This is an unlikely phenomenon that is neither readily apparent nor easily detected in the cave-like gloom of the windowless attic, but had he suspected its existence we can be certain that he would have investigated it with vigor. Hence, he could not have known that the first roof, which would have been no more than, say, two years old by the outbreak of the Civil War, still possessed the abundance of delaminating slate on its slopes and remnants of sheet lead in the gutters that we see there today. Moreover, the coating of soot found on the parapet walls between the old roof and the new is the accumulation of decades, not just one or two seasons, so that the addition of the second roof was by no means immediate, but some time prior to 1882 and the "Glaston" drawing (figure 15). The first metal membrane on this new roof would, indeed, appear to have been standing seam copper (see figure 27), and when this failed it was replaced by terne metal, but not before 1902 at the earliest, when Follansbee Steel, the terne metal manufacturer, first established its plant in West Virginia.

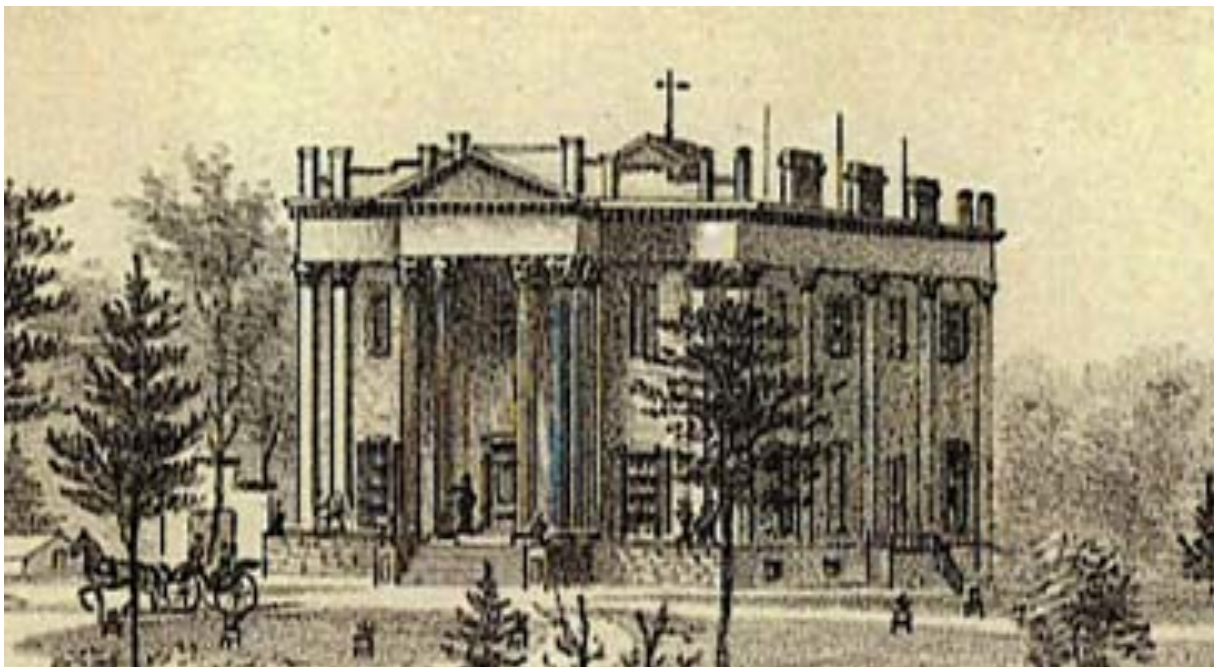
About twenty years later, probably following closely upon the conversion of the twelve fireplaces from wood-burning to coal hearths, and certainly by 1882, the date of the drawing in Figure 28, a second roof system had been superimposed over the first, its much shallower slopes apparently clad with copper and falling from the ridge flat to the tops of lowered parapet walls, then draining into newly constructed, shallow box gutters built on the cornice of the original entablature outside the walls. Portions of the North and South gable walls show clear

Figure 28. Detail from the drawing in W.H. Perrin's 1882, *History of Bourbon, Scott, Harrison and Nicholas Counties*, seen in figure 15 above.

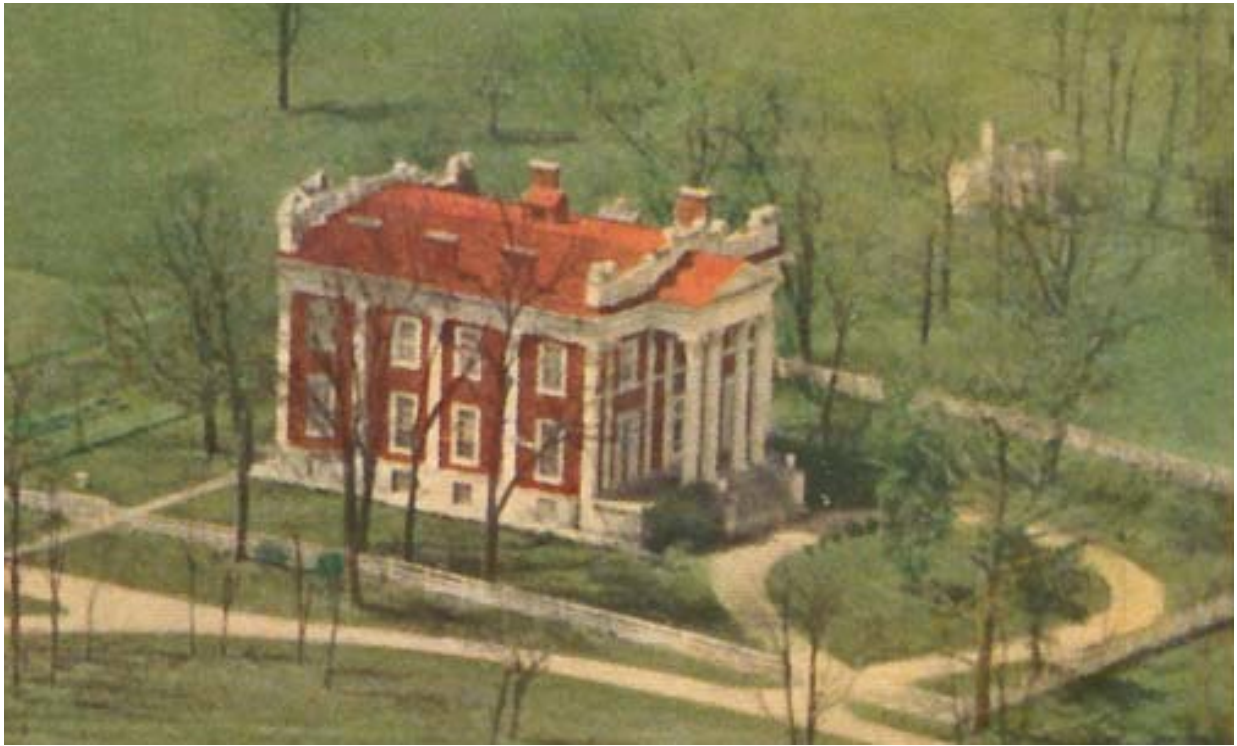
Later, the false stack in the center of the West wall was taken down, as seen in Figure 29. In more recent times, certainly after this 1940's photograph was taken, the limestone caps to the five remaining stacks in the East and West walls.....

Figure 29. Detail from the 1940's aerial view of Ward Hall from the Northeast, seen in figure 18 above.

were removed and replaced with brick. These stacks have been subjected to various crude attempts at repair with Portland cement mortars and are now in very poor condition. So too, are the pilaster capitals and much of the classical entablature below the stacks..

Next, masons employing their own, additional scaffolding from the cornice level of the house on up, will dismantle and rebuild all six chimney stacks, recovering and cleaning as much of the original brick as may be possible, mixing in other, closely matching old brick as necessary, and capping the rebuilt stacks with newly fabricated limestone replicas of the original caps. These caps appear in Figure 1, and one or two of their broken components have been located in the foundation of a former henhouse, about 150 yards away from the mansion. Since each of these stone elements will weigh about 500 pounds, a mobile crane will be used to facilitate setting them in place. The portions of the North and South gable walls that were raised to conceal the higher, second roof profile will be taken down, and the top courses of the original parapet walls that were taken down to cornice level to facilitate the second roof's construction, will be rebuilt with limestone coping stones to match the original, their height to coincide with the limestone string courses built into the outer flanks of the North and South gable ends. The mortar will be an appropriate lime mortar in compliance with The Secretary of the Interior's Standards for the Treatment of Historic Properties. The finish joints will be struck and ruled to match the original masonry joints. This work is expected to take between 15 and 20 days and to cost of approximately **\$75,000.00**, of which about \$15,000.00 will be expended on materials: matching bricks, dimensioned limestone and mortar.

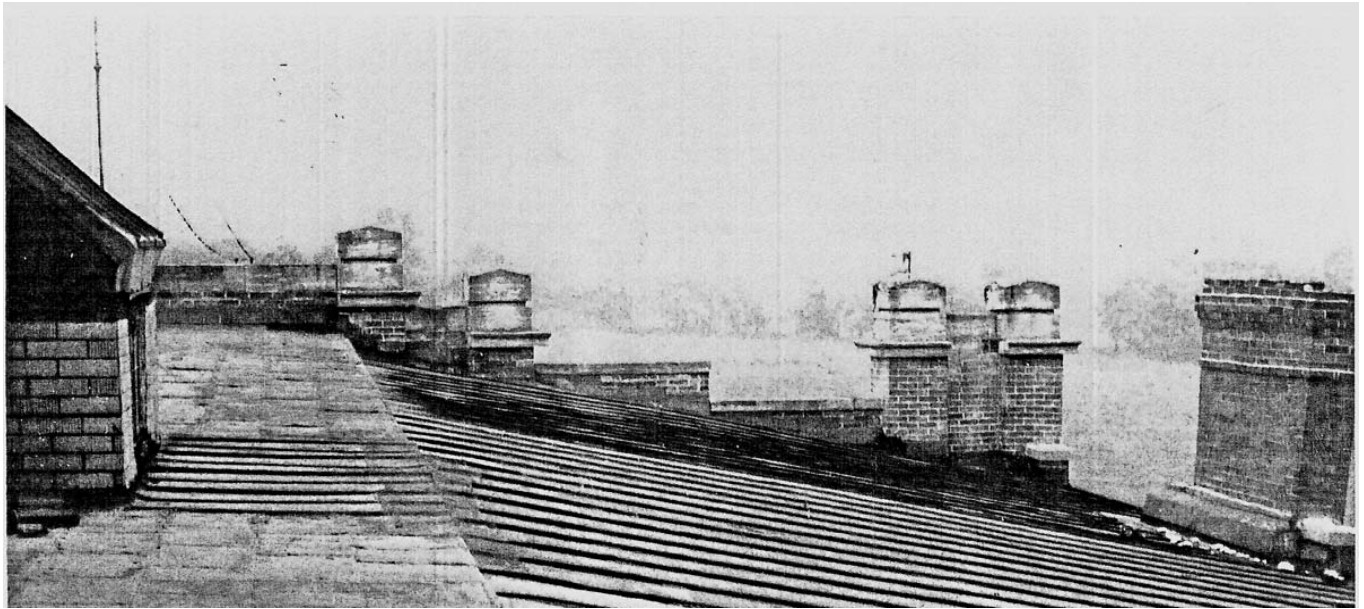
system has entirely supplanted any concern for the provision of daylight to the major vertical circulation system of the house, and the incongruous and leaky appendage presently found on the attic landing roof more closely resembles an abandoned dog kennel, inexplicably put back into service up there, than the proud ornament that so frequently crowns Greek Revival buildings.

Figure 38. A vintage photo of unknown date, but taken after the chimneys had lost their coping stones, and showing the first cladding surfaces to the second roof – appearing to be a medley of original lead to the ridge flat and standing-seam copper to the slopes -- and in which an extremely tall penthouse exhibits no ambitions to offer the Attic below the amenities of a lantern, but appears, instead, to be built of brick or block. Note the raised half bay in the lower gable wall. *Photo, Ward Hall Archives.*

A sum of **\$18,500** has been allowed to build, ship and install a replacement lantern.

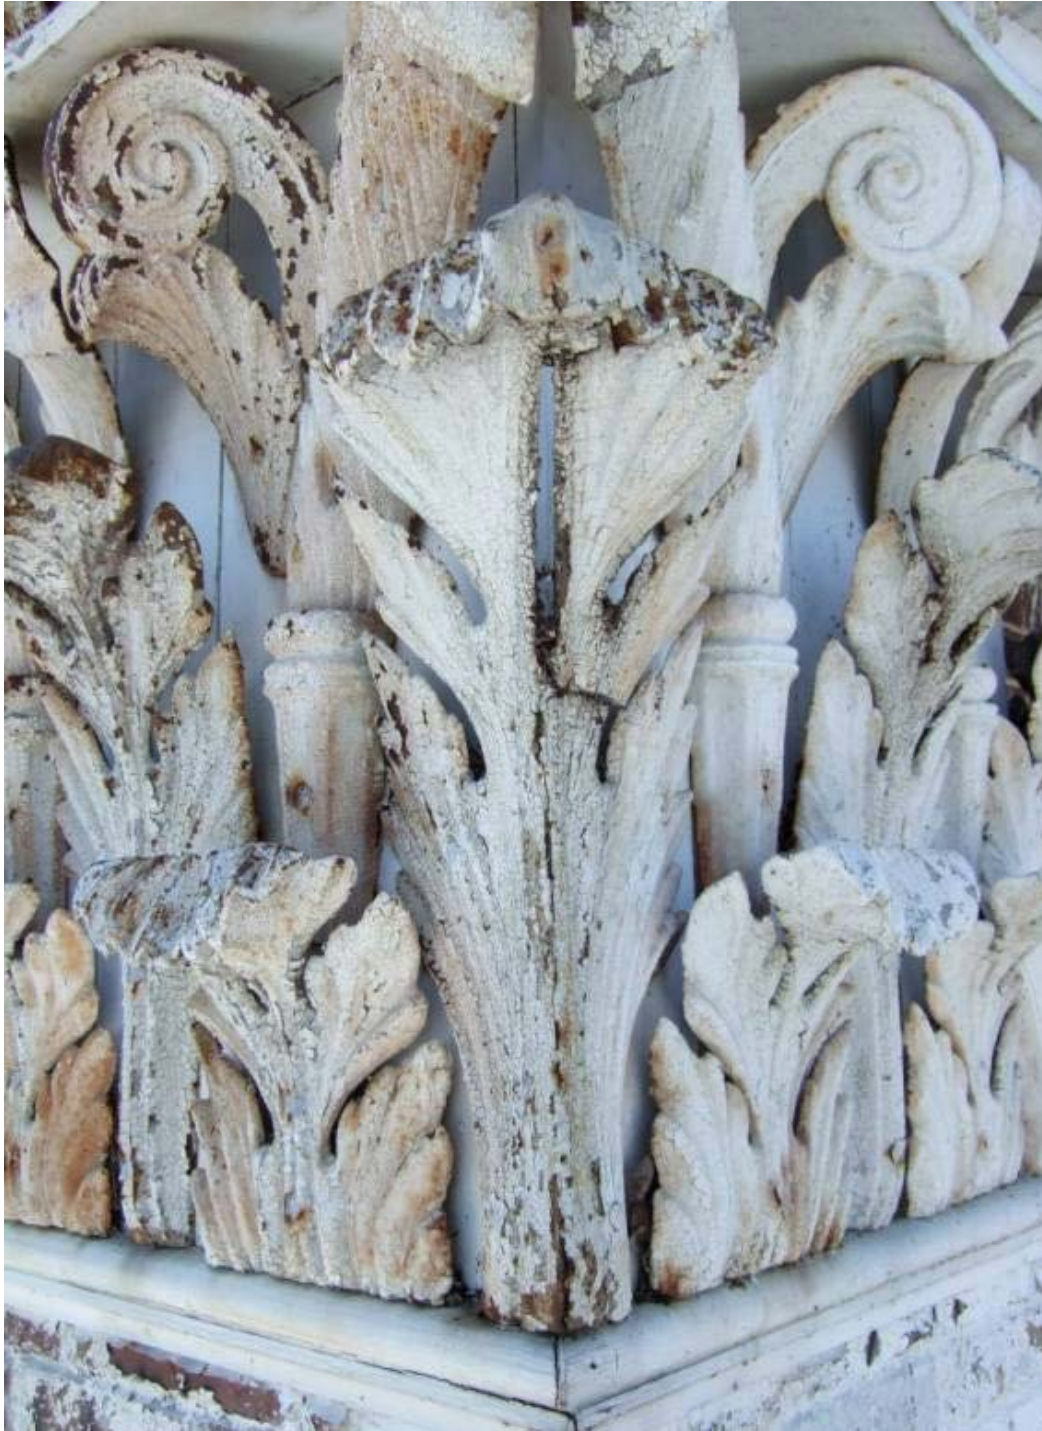
Figure 44. Corner pilaster capital, detail.

Alison Brown's study for the *Conservation of the Cast Iron Pilaster Capitals at Ward Hall in Georgetown, Kentucky*, a 2007 Masters Project in the University of Kentucky Department of Historic Preservation, provides a reliable basis for estimating the probable cost of replacing the broken and missing components of these capitals. The four elevations of the house comprise a total of twenty-six pilasters crowned by Corinthian capitals, all but the corner pilasters containing fourteen separate pieces of cast-iron acanthus leaf ornamentation, attached with screws to a robustly constructed timber substructure.
